Bourke Shire Council

Pedestrian Access and Mobility Plan Draft Report, March 2014

Accessible Public Domain

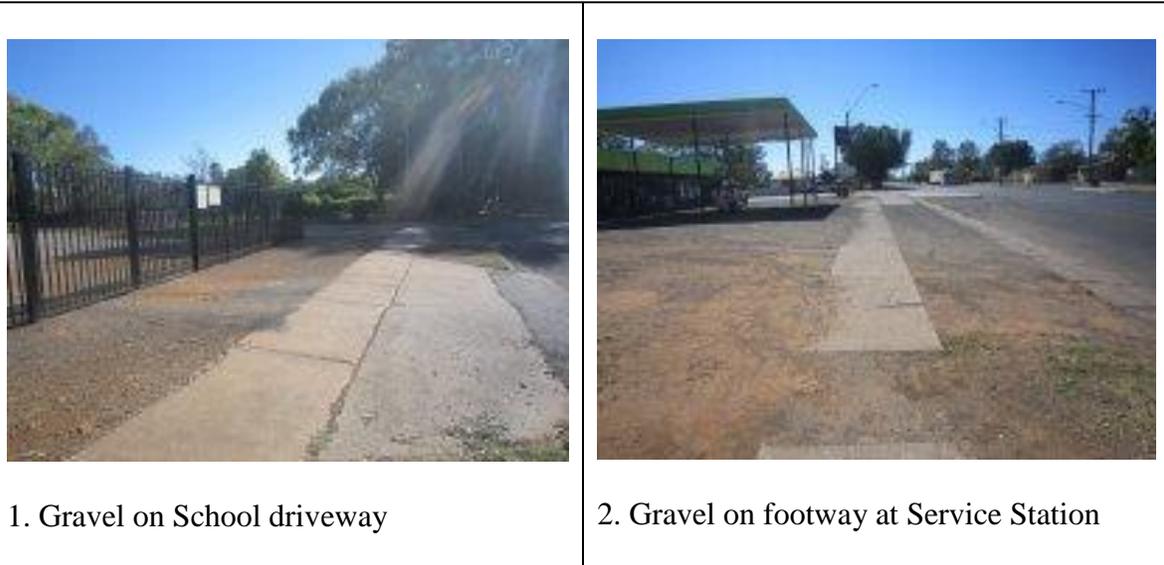
- Gravel on a hard surface presents a potential slip hazard for every pedestrian. (See photographs 1 and 2)
- Glass on footways and roadways presents a hazard for pedestrians and drivers

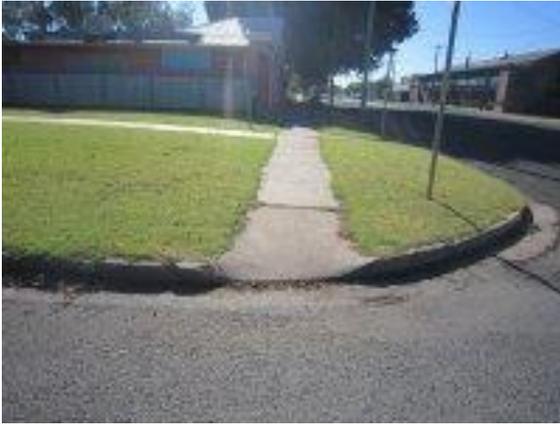
Lips also present a hazard for aged pedestrians, people who have an ambulant disability or people who are blind or have low vision, particularly if the kerb ramp is in shadow. The lip could result in a person tripping onto the roadway. It is considered that the removal of these asphalt lips is a high-need, low-cost action.

3. Kerb ramp with lip.

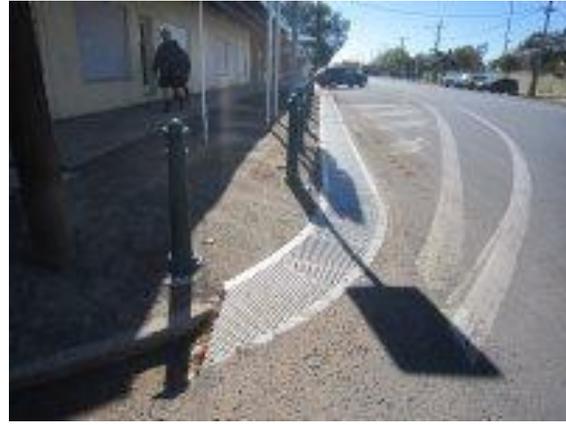
4. Steel mesh over gutter is an effective means of providing access where the road camber is steep, provided that pedestrians are directed to a crossing point by a path of travel.

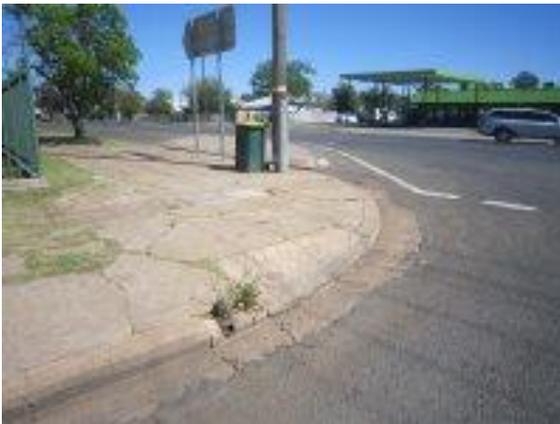
The apron on the kerb ramp in **photograph 5** is too steep. The maximum gradient of a kerb ramp is 1:8. Kerb ramps in the same material and colour as the surrounding footway do not provide a tactile or visual cue to pedestrians with vision impairment that they are approaching, or on, a kerb ramp.

5. Steep apron on kerb ramp

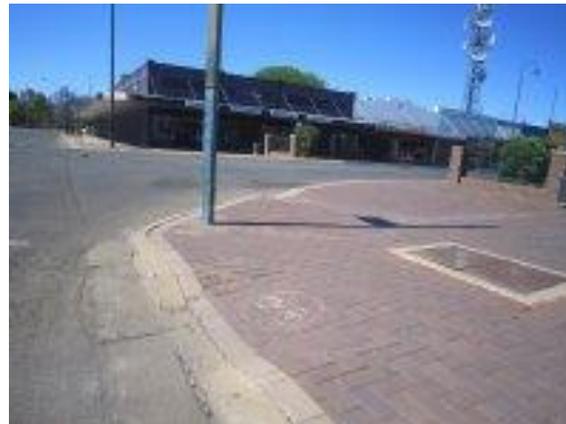
6. Kerb ramps in same material as footway

Concrete kerb ramps in locations such as that shown in **photograph 6** would assist in safety and orientation.

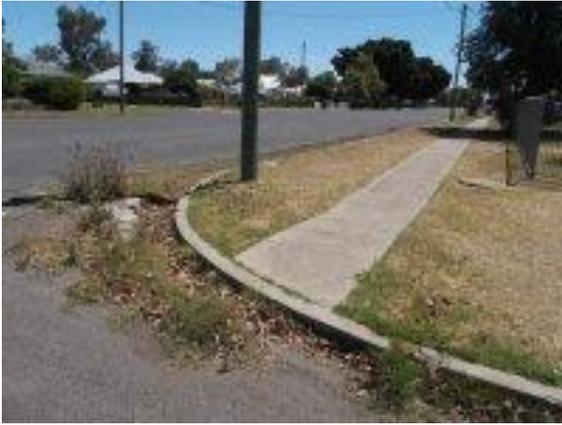
7. No kerb ramp to paved footway

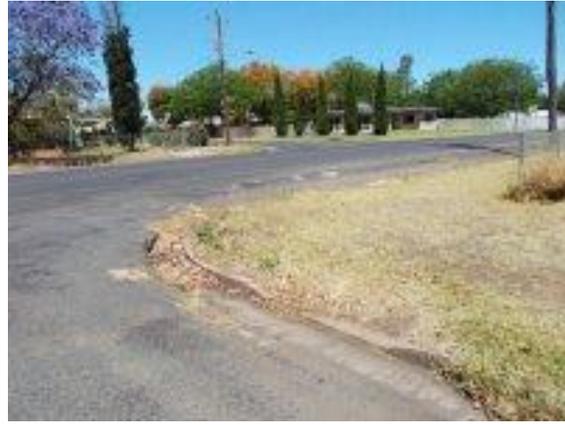
8. No kerb ramps or paved footway on corner

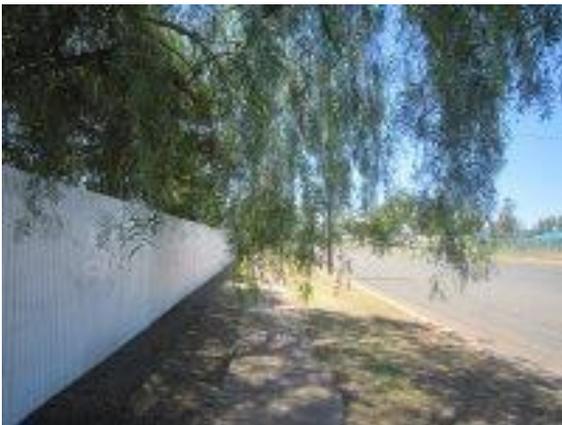
9. Tree from private property overhangs footway

Trimming of trees, the removal of overhanging foliage and the removal of grass and weeds from footways are considered to be high-need, low-cost actions.

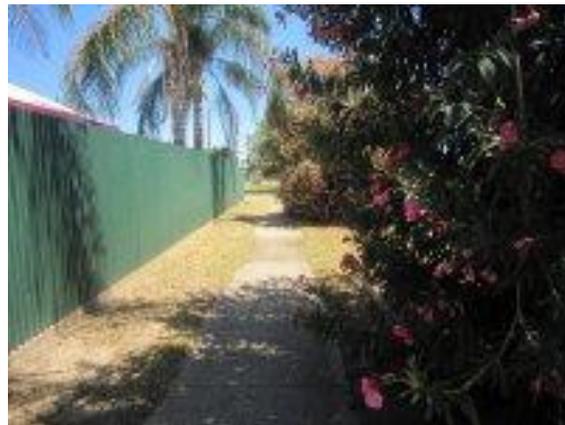
10. Street trees block paved footway

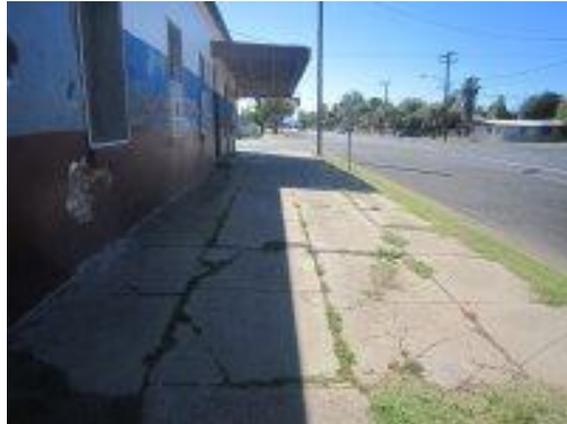
11. Grass growth in joints is a potential trip hazard

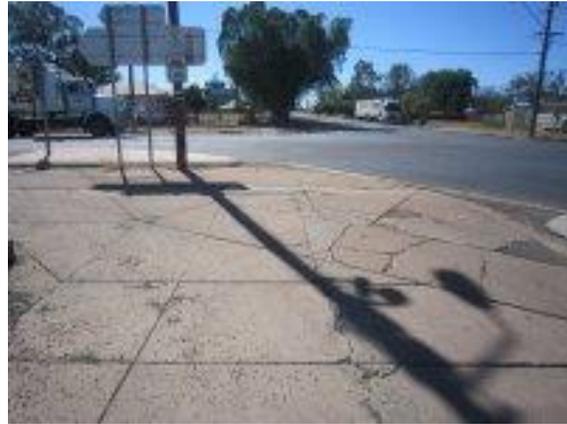
12. Footway with wide joints and severe cracking needs reconstruction

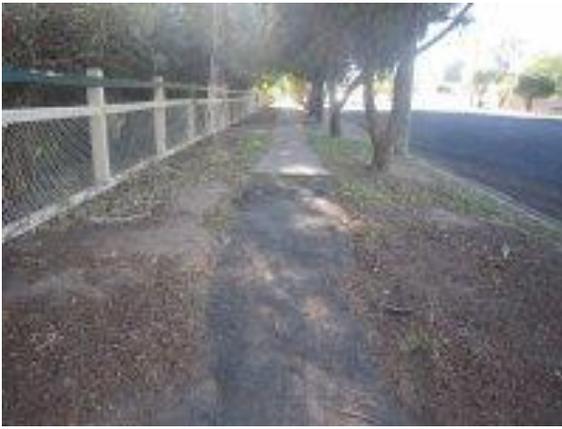
13. Asphalt footway in poor condition because of tree root activity

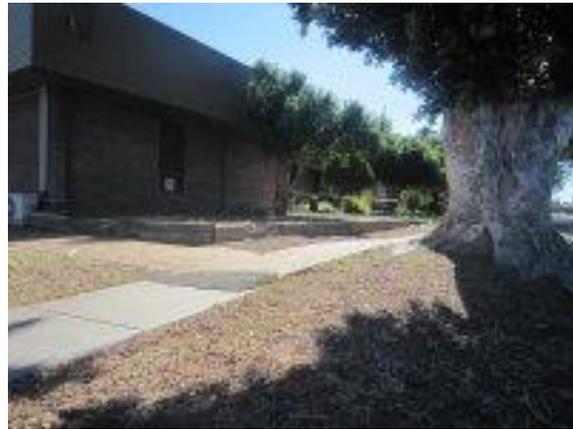
14. Footway slabs lifted by tree root activity, creating a fall hazard for pedestrians, and a tipping hazard for people who use a wheelchair

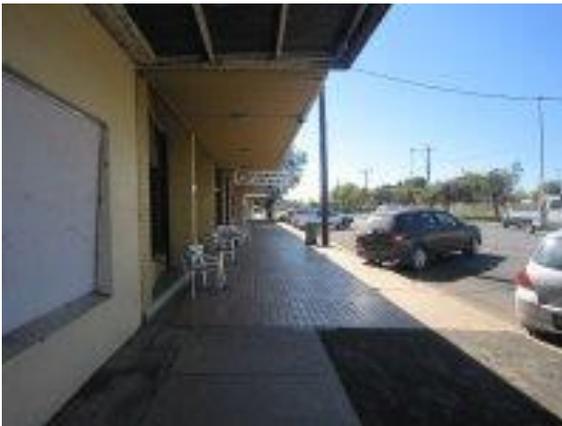
Outdoor dining areas and obstructions such as A-frames are particular hazards for people with vision impairment, people who use a wheelchair or mobility scooter, and parents with strollers. A collision between a person with vision impairment and a chair or table may also be a hazard for the diner.

15. Outdoor dining not protected by end barriers

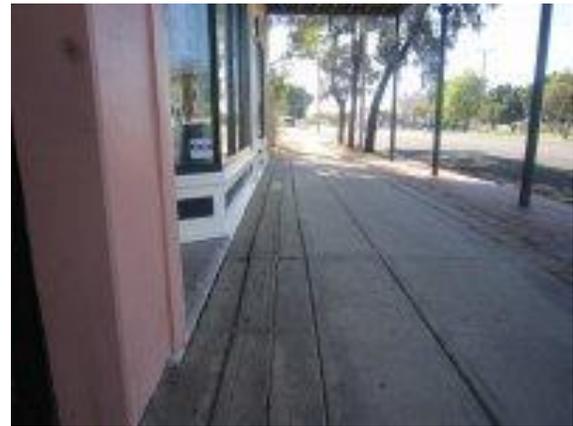
Wide joints or cracks pose a potential hazard for people who use wheelchairs or mobility aids such as crutches, walking sticks or long canes. **See photograph 16.**

16. Wide longitudinal joints a hazard for people who 'shoreline'

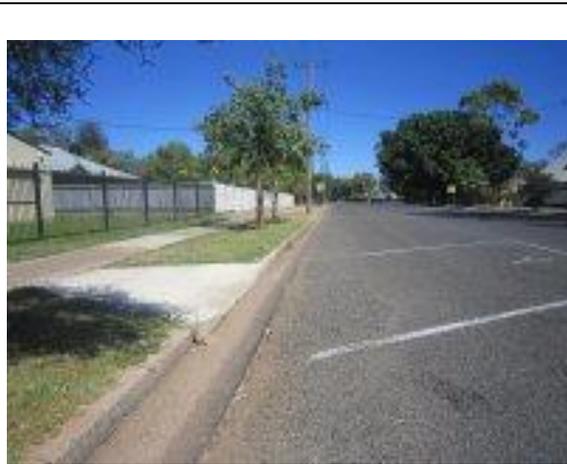
17. Light traffic street. Accessible parking space parallel to kerb, with the kerb ramp at its rear, is preferred

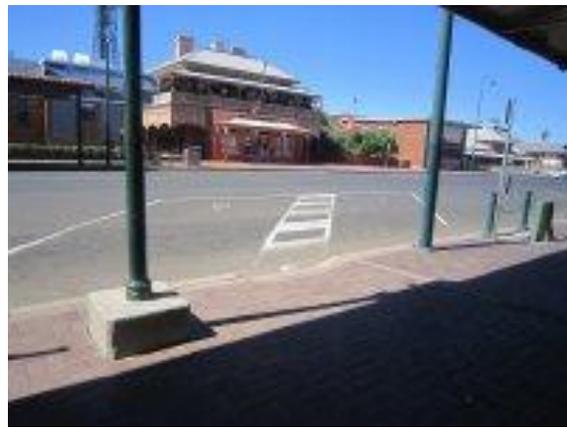
Australian Standard AS/NZS 2890.6 (2009) requires an Accessible Parking Space to have an adjacent Shared Area into which a roof-mounted wheelchair can be lowered, or in which a person can transfer from the vehicle to a wheelchair. The shared area is to have the same dimensions as the parking spaces and is required to have a bollard at its front end to prevent parking in the space. (See **photograph 18**)

18. Shared space between accessible parking spaces does not comply with Australian Standards

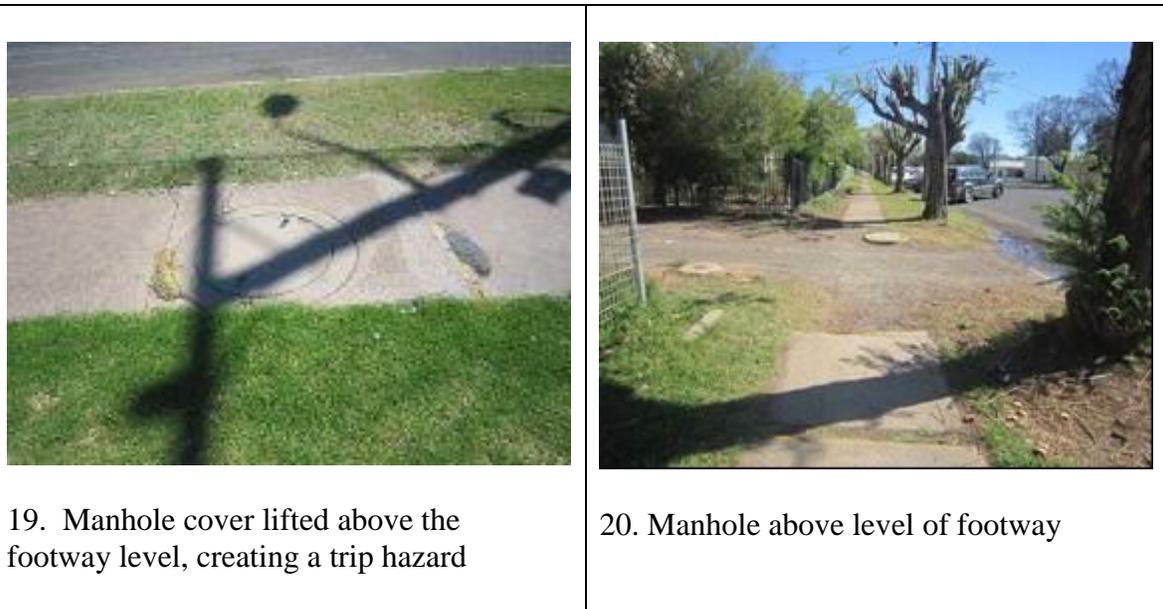
A number of manhole covers and service pits within a path of travel were observed to be damaged. Following their repair, Council will need to undertake minor maintenance. The requirement for individual Service Authorities to undertake repairs to their assets is considered to be a high-need, low-cost action. **See photographs 19 and 20.**

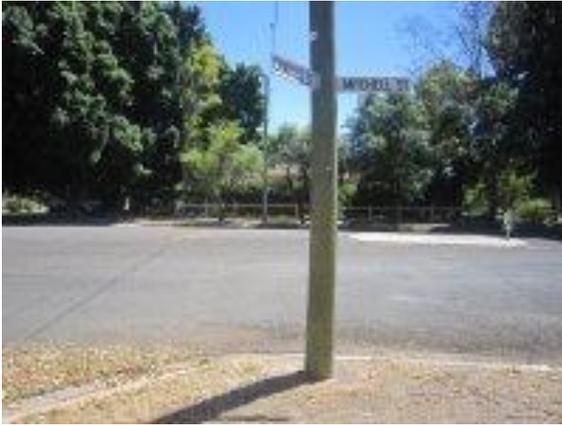
The provision of street name signs is important for visitors. If they are located on a pole at the same height one may be difficult to read as it is hidden by the other. This could create a hazard for pedestrians and drivers as the driver is distracted in trying to read the other sign. **(See photograph 21).**

21. Street name signs at same level are sometimes difficult to read for drivers

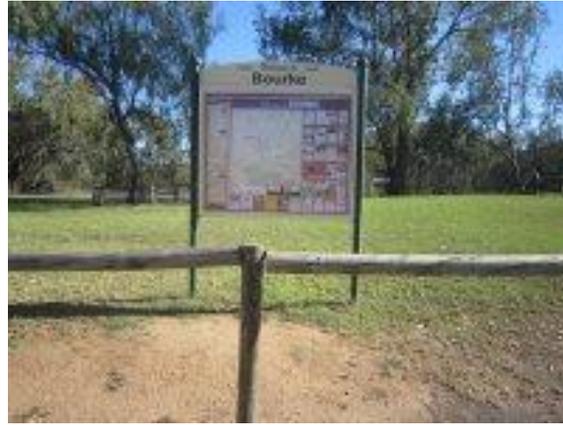
The location of directional signage, such as the Tourist Map in **photograph 22**, should be located adjacent to a hard stand area that is connected to an accessible path of travel, so that people who have a physical disability or impaired vision can read the map and information at close range.

22. Important information sign is not accessible

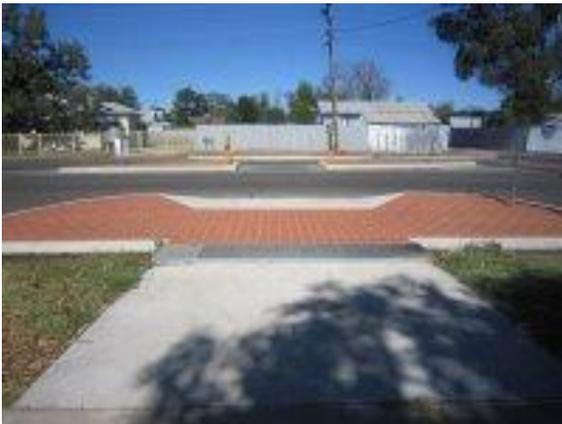
23. TGSIs required in this refuge near a Child Care Centre

TGSIs are also required to be placed 300 mm from each edge of, and within, a walk-through in a median, or a pedestrian refuge. **See photograph 23.** They are also required at the top and base of ramps and steps, see Access Audit Report comments about the PCYC, and at locations such as that shown in **photograph 24.**

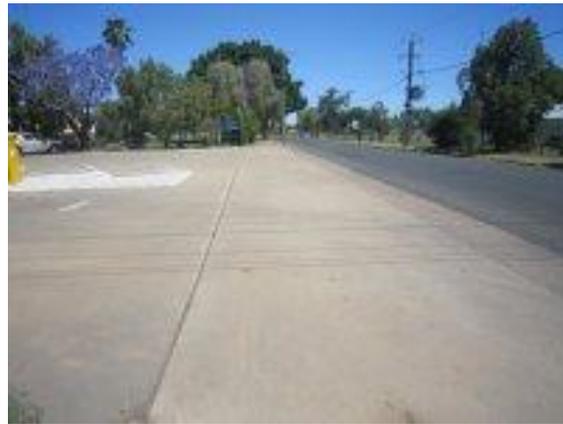
24. Refuge and TGSIs required between the In and Out driveways of the Health Services in Tarcoon Street

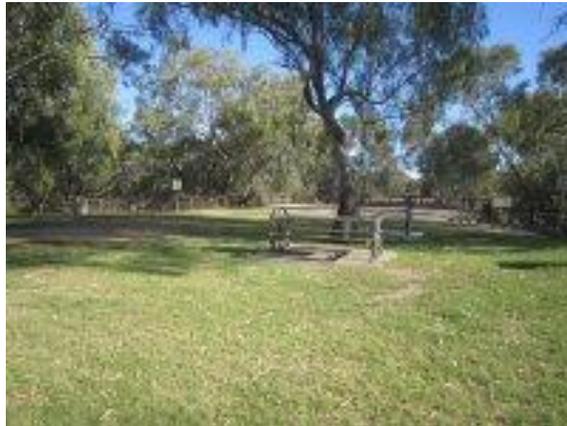
25. Some of the picnic tables at the Wharf should be connected to an accessible path of travel, and some of them should be modified to become wheelchair accessible

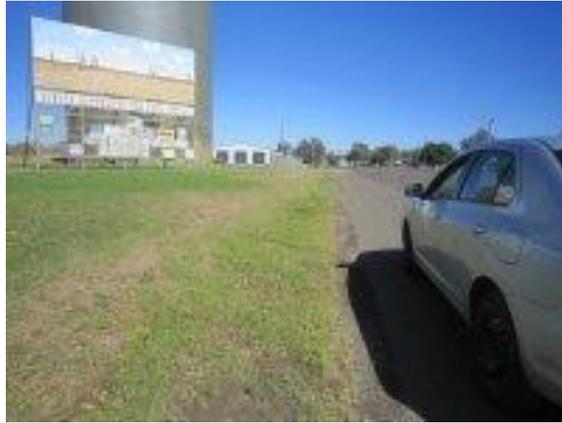
27. But the Information Board is not accessible.

From a Tourism perspective, it is recommended that kerb and gutter be constructed in Anson Road in the vicinity of the Information Board, with a standard kerb ramp, accessible pathway and circulation space provided to the Board, with an accessible pathway to the picnic facilities.

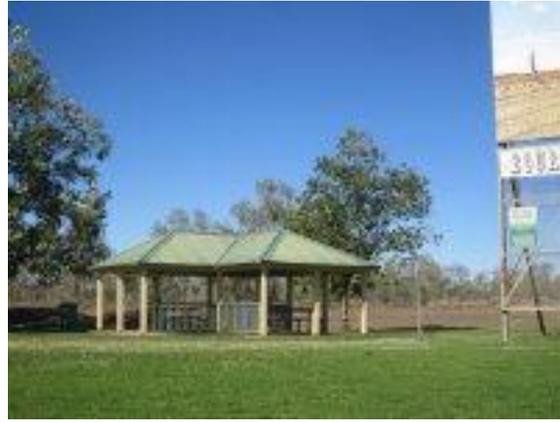
28. Nor are the picnic facilities nearby.

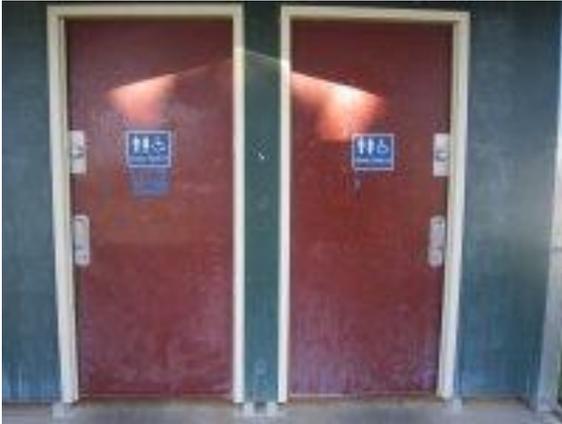
29. Unisex Accessible Toilets are most appropriate for tourist destinations. These doors should open outwards to provide sufficient circulation space inside the cubicle.

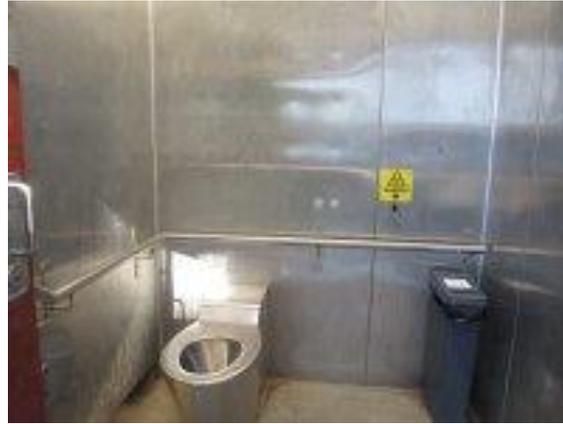
- Signage on the doors is incorrect. The sign that indicates a Left-hand transfer is on the cubicle that provides for Right-hand transfer, and vice versa. Left-hand transfer means that a person moves from a wheelchair to the WC pan in a right-to-left direction, that is, by the use of the left hand. (See photographs). The signs should be swapped over.
- The cubicle doors open inwards. This restricts the circulation space for a wheelchair within the cubicle when the door is open. The doors should be re-hung so that they open outwards. This would also allow a person who uses a mobility scooter to take the scooter into the cubicle for security and convenience.

30. Left-to-right transfer WC pan. (See comments in Access Audit Report).
