Bourke Shire Council

Pedestrian Access and Mobility Plan Draft Report, March 2014

Accessible Public Domain

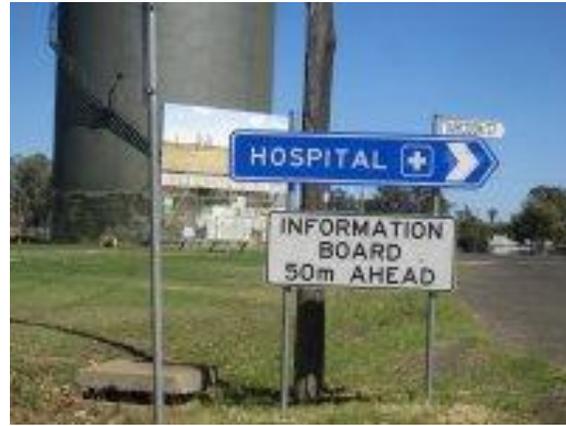
26. This sign on the Mitchell Highway, at the entrance to the Bourke Township from Nyngan, advises the location of an Information Board.
